Manhole Inspection Summary

Manhole # S1900_032MH

Location Address: **2426 REISTERSTOWN-MONROE** Cross Street: **BRYANT AVE**

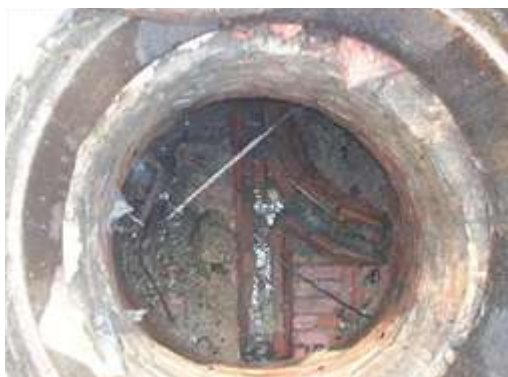
OFFSET CHANNEL. DEBRIS ON
BENCH AND CHANNEL

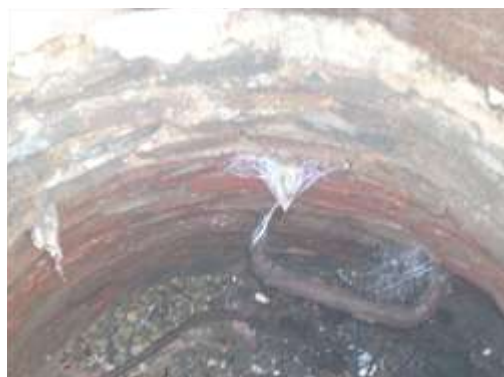
Defect 3

Steps Count: **1** Missing: **1** ☒ **Corroded**

MISSING AND CORRODED STEPS

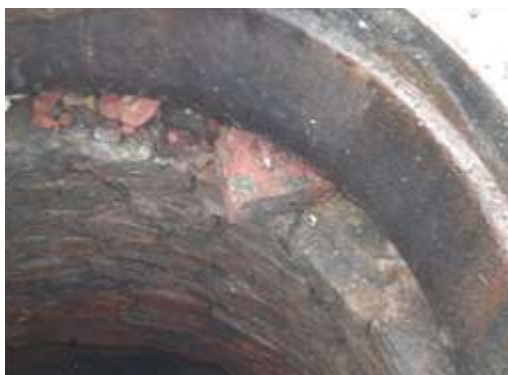
Defect 2

Chimney / Frame Adjustment ☒ Exists Material: **Brick and Concrete** ☐ Parged Height: **3** (in.)
Condition: ☐ Sound ☐ Cracked ☐ Root Intrusion ☐ Loose Brick ☒ **Deteriorated**
Infiltration: ☒ None ☐ Joint ☐ Cracks ☐ Mortar ☐ Roots ☐ Wall

DETERIORATED FRAME ADJUSTMENT
AND CHIMNEY

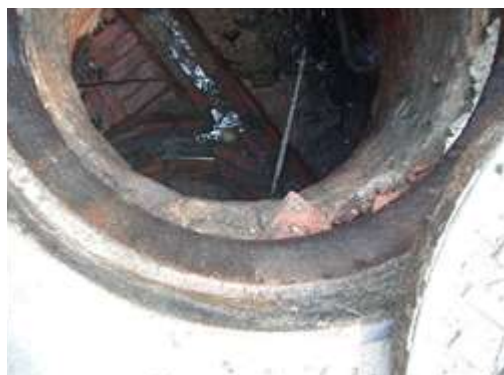
Defect 1

Frame Offset: **1** (in.) Condition: ☒ Sound ☐ Cracked ☐ Leaks

FRAME OFFSET

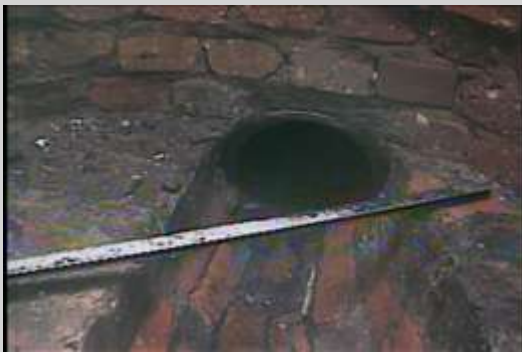
12 O'Clock Outflow

Pipe Height: **8.4** (in.) Rod and Bar (Angled)
Pipe Material: **Clay** ☐ Pipe Lined
Invert Depth: **6.82** (ft.) Flow Characteristics: **Slow**
Deposits: ☒ None ☐ Mud ☐ Sludge ☐ Debris ☐ Grease
Silt Depth: (in.) Deposits Extent:
Infiltration: **None** Pipe Seal Cond: **Sound**

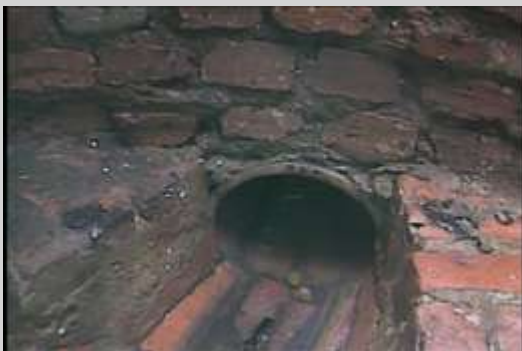
3 O'Clock Inflow

Pipe Height: **8.4** (in.) Rod and Bar (Angled)
Pipe Material: **Clay** ☐ Pipe Lined
Invert Depth: **6.73** (ft.) Flow Characteristics: **Slow**
Deposits: ☒ None ☐ Mud ☐ Sludge ☐ Debris ☐ Grease
Silt Depth: (in.) Deposits Extent:
Infiltration: **None** Pipe Seal Cond: **Sound**

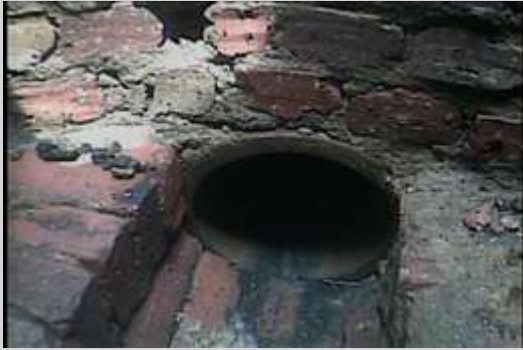
6 O'Clock Inflow

Pipe Height: **8.4** (in.) Rod and Bar (Angled)

Invert Depth: **6.46** (ft.) Flow Characteristics: **Slow**

Infiltration: **None** Pipe Seal Cond: **Sound**
